CASE STUDY

SUBSIDENCE REPAIR, GROSVENOR ROAD

Project: Stabilisation of former railway ticket hall

Location: Grosvenor Road, central London

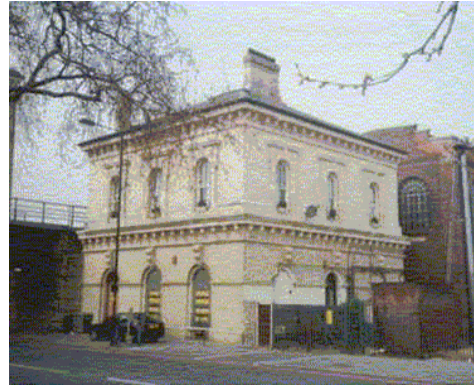
Almost 150 years after it was built, the ticket office was showing its age. A high water table, trundling trains, and poor fill around the site were taking their toll.

Not only was the ground below the building poor, the structure sat on rotting timber piles. There were voids forming below the timber. The ground was disappearing from underneath the wooden piles and the high water table in the fill didn't help.

These voids needed to be grouted before any structural work could be carried out. But the poor quality of the ground meant that there was a real danger of the grout bubbling back up to the surface, like boiling mud at a geothermal park. To combat this we capped the area with 125cu.m. of lean mix concrete. This acted as a surcharge on the fill and ensured that the grout did not find its way back to the surface. Effectively it put a lid on the area. We then drilled through the concrete and grout the deep voids below it.

We used almost 20 tonnes of OPC/PFA grout, a mixture of pulverised fuel ash and ordinary Portland cement across a 450mm grouting grid throughout the site to stabilise it.
