# VAN ELLE

# BRICKBEAM<sup>®</sup>

## POST-TENSIONED MASONRY SYSTEMS

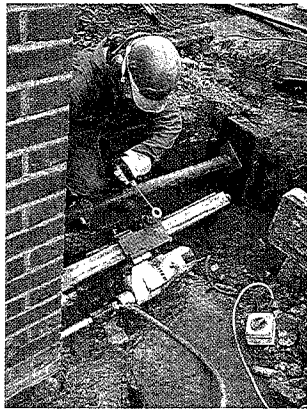
*Diamond coring in process below ground level through masonry.*

As noted above, the system's installation is a relatively simple process. Initially a shallow pit is excavated to expose the sub structure masonry and allow siting of the drilling rig. Coring is undertaken through the sub structure, open cavities or voids being grouted if required. The sub structure is locally broken out to allow fixing of the dead end anchorage, a tendon and live end anchorage are located, and following tensioning, the substructure brickwork is made good along with the repair of fractured masonry above ground level.

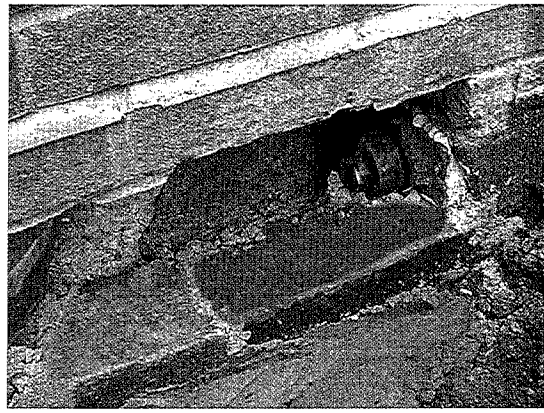
*Tendon located within cored duct and dead anchor plate positioned.*

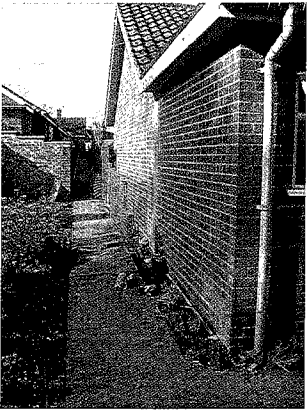
*Installation in progress, note lack of disruption.*

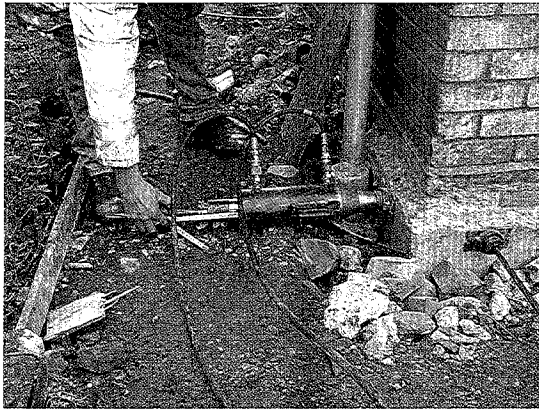
*Post tensioning in progress.*
