CASE STUDY

NORTH BERWICK HARBOUR WALL REMEDIATION

Project: Stabilising & re-pointing of the harbour wall face and removal of the existing, and installation of the new, stop log channels and crane foundations.

Location: North Berwick, Scotland

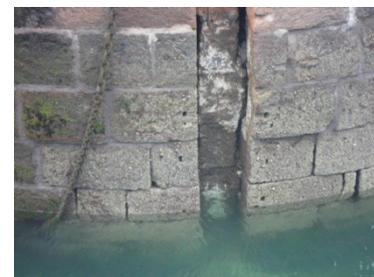
The original stop log channel.

Stop log channels are inset into either side of the harbour entrance and the stop logs are lowered into position in heavy seas to reduce wave action in the harbour. There is a manually operated stop log crane at the end of the South West pier, just visible in the above photo.

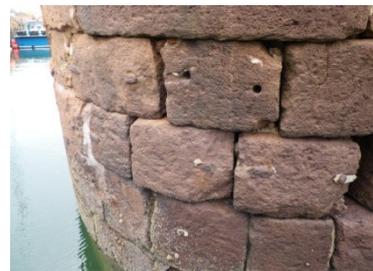
Roundhead of pier prior to re-pointing.

1. A survey of the stop log channels.
2. A survey of the stop logs.
3. Fabrication of a steel stop log retrieval beam.
4. Re-pointing of the joints between the masonry blocks, for a 10m length from the pier's roundhead.
5. Grouting the core of the wall, to fill any possible voids, for a 10m length from the pier's roundhead.
6. Replacement of the stop log channels on the South West and North West Pier.
7. Removal and disposal of the existing stop log crane.
8. Replacement of the concrete foundation for the stop log crane.
9. Replacement of the crane.

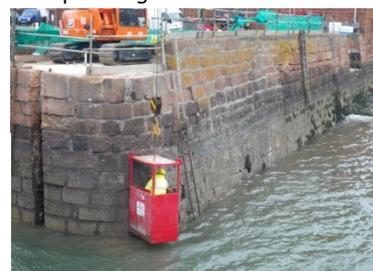
Hoisted by a mobile crane & re-pointing the harbour wall.

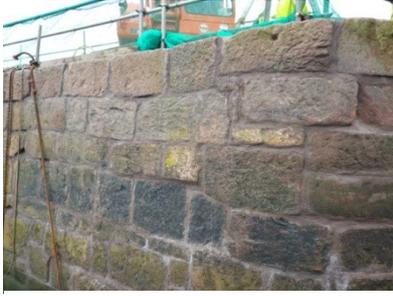
The South West pier harbour wall after having been re-pointed.

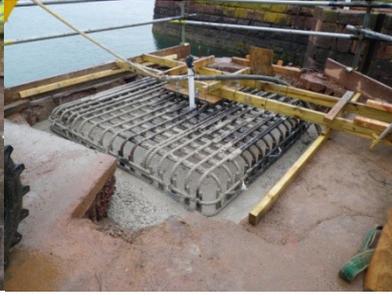
The steel reinforcement for the foundation of the new pier crane.

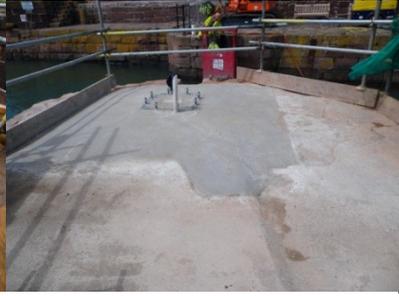
The new pier crane foundation having been concreted and awaiting the arrival of the crane itself.

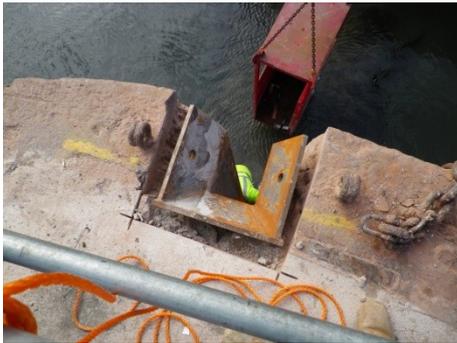
Left: One of the two stop log channels being checked prior to being grouted into position.

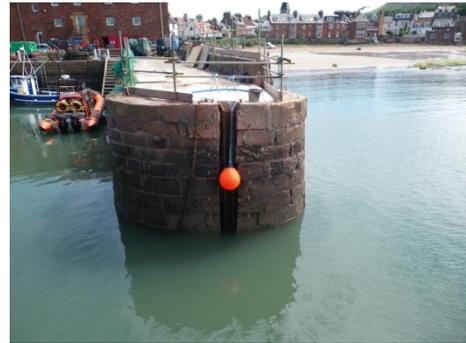
Right: One of the completed stop log channels installed at the end of the pier roundhead.

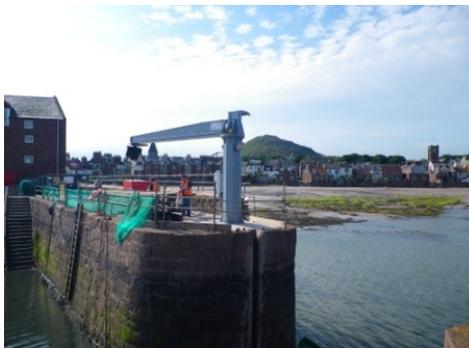
The crane fully installed and operational.

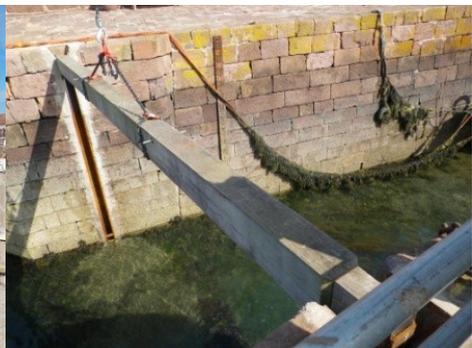
The first stop log being lowered into position in the stop log channels.
