## Grouting & Hoopsafe® Subsidence Repair

### GROSVENOR ROAD

*Solution*  
*Hoopsafe® Post-Tensioned*  
*Repair System*  
*20 Tonnes of OPC/PFA*

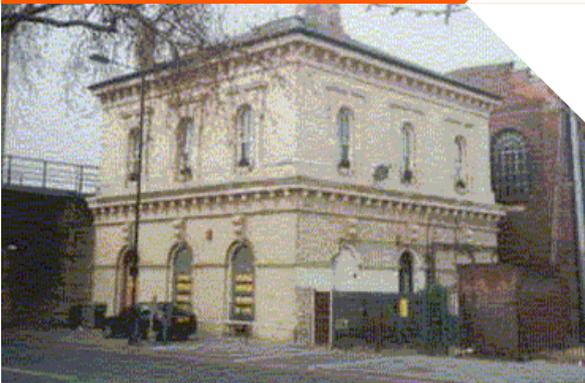
We tensioned up to 50% of the final load on all of the beams, positioned the locking wedge and then tensioned up to the full load. This allowed for any relaxation in the wedge. The tendons were checked to ensure they had reached their 'theoretical extension' by measuring the length before and after tensioning. The difference between the two measurements should be 7mm per metre of beam. Its like a cooper putting a metal ring on a beer barrel; the building behaves as a single unit again.

Normally the system uses an external, reinforced ring beam to help stiffen structural walls, rather like a corset. But at this site we used a 'belt and braces' approach by placing a beam on each side of the external wall. It gave the building a new foundation as well as corseting around it. The frame for the inner-leaf refurbishment now sits on the beams.

The beams themselves measured 450mm square, with a 16mm diameter reinforcement steel cage and were formed flush against the original walls. Seven-strand Dyform tendons were fixed to the reinforcement cage before the concrete was poured. Six steel strands were woven around the central 'king' wire before they were tensioned by a hydraulic jack, bringing the beams into compression.
